Borehole water supply protected by new water treatment system, keeping production running for leading food manufacturer

Tackling iron and arsenic to meet drinking water standards

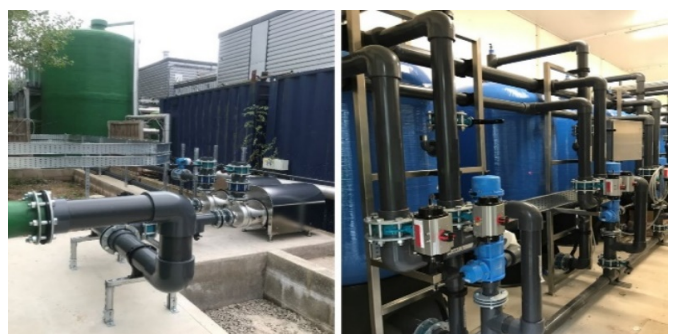
The new water treatment plant:

- Pumps the borehole water supply to an inlet break tank which is pre-dosed with sodium hypochlorite and ferric sulphate, to oxidise iron, manganese and arsenic and convert them from soluble to insoluble ions. New borehole water pumps were installed, as well as PVC pipework for one borehole where existing pipework had corroded.

- Another set of high-pressure pumps then sends the treated solution through one of four filtration beds containing catalytic media. This media captures suspended solids. With a much lower footprint than traditional media, this system helps to reduce the overall size of the plant and work within the restraints of the site area.

- The water is then passed through pressure vessels containing ion exchange resin to remove hardness, substituting calcium and magnesium ions with dissolved sodium ions.

- As a final sterilisation stage, UV filters remove any remaining microorganisms not killed by the chlorination stage.
- The treated water is tested for free available chlorine, pH, hardness and iron concentration before passing into the treated water tank.
